S7 operation update

Eric Dufresne, TRR group meeting, April 6, 2004

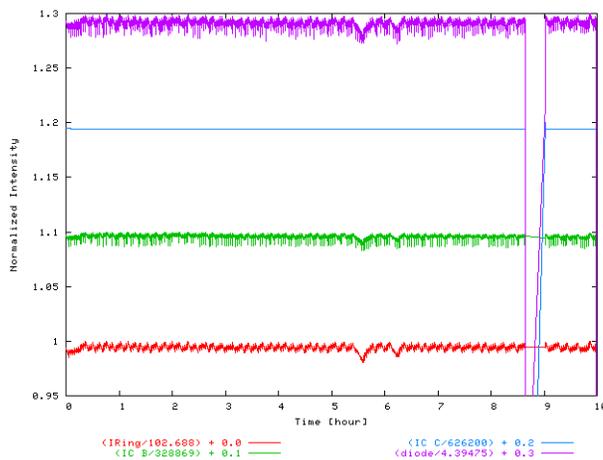
Intensity plots
On 3/21/04

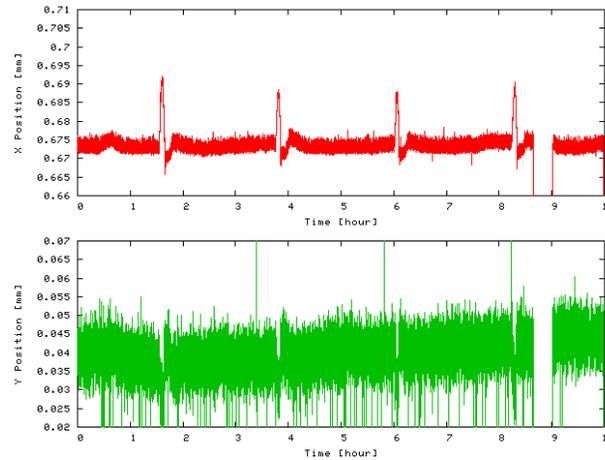
Beam position
On 3/21/04.
3 hours period
beam motion
correlate with
cryocooler fill.

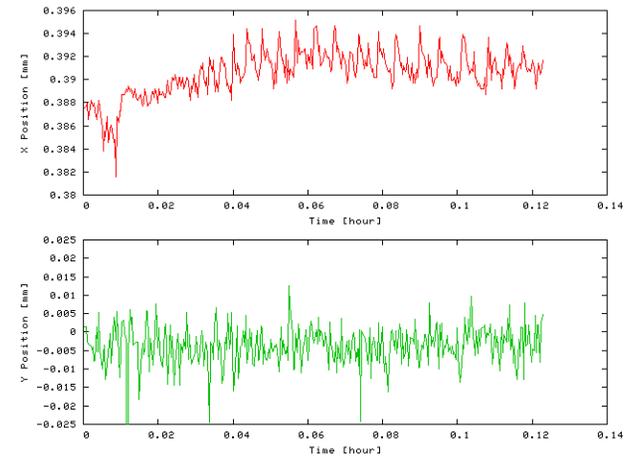
Short time scale
Fluctuation, 5 um
horizontal motion
due to closed loop
heater turning on/off.

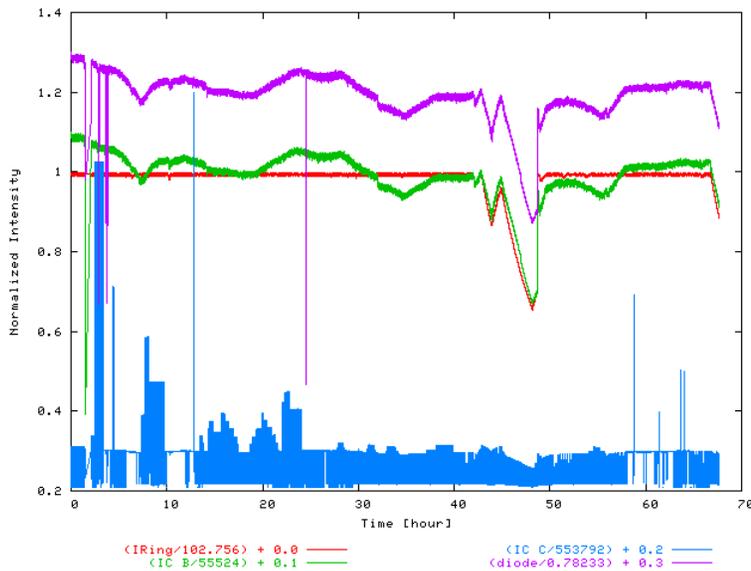
Beam stabilized by constant pressure circuit

Intensities on week of 4/1/04 for 2.8 days. Note top-up failure Near $t = 42$ hrs.

Beam position data week of 04/01. Note beam motion when top-up fails.

- Within the last week, we have tested a new pressure stabilization circuit which has improved the beam stability 5 fold. For more details see <http://www.mhaff.aps.anl.gov/operations/FY04/run2>
- On 4/5/04, we prevented a catastrophe by replacing a broken solenoid on the cryogenic input lines to the cryocooler in 7ID-A.

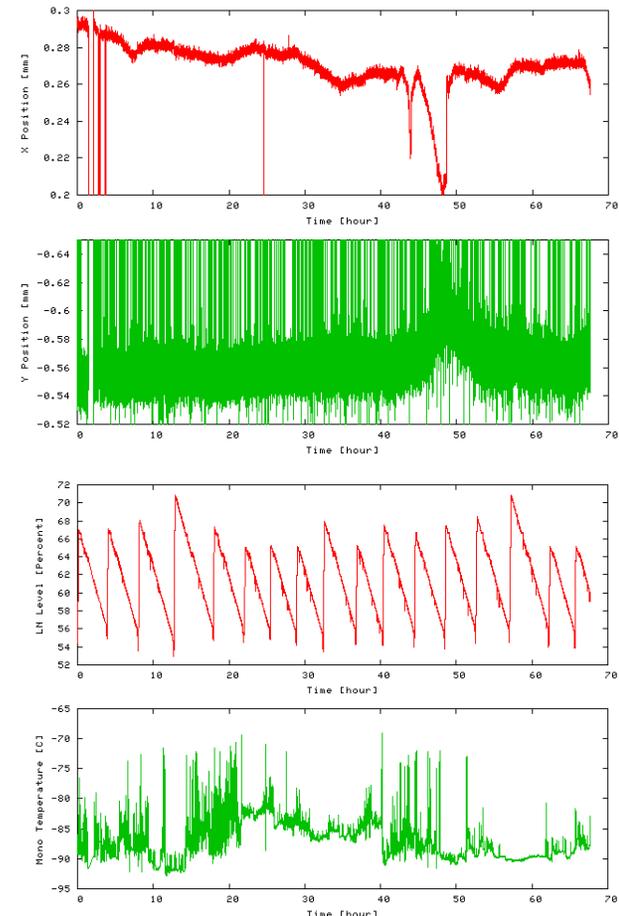
Cryocooler Level sensor data

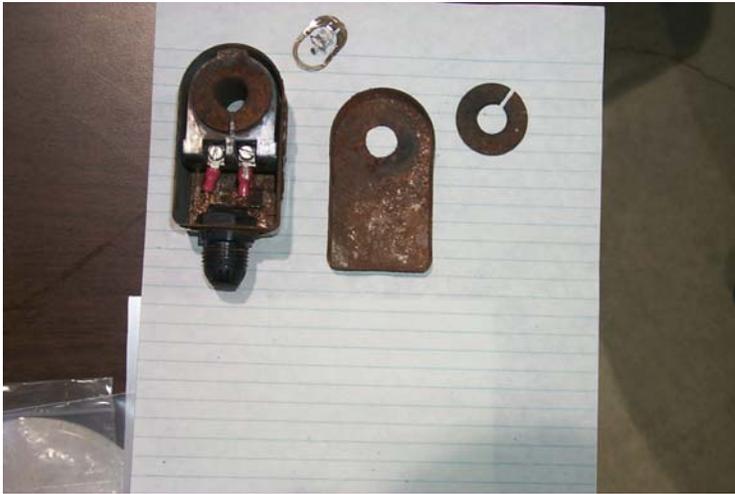
Old rusted defective solenoid

Old rusted solenoid replaced on 4/5/04

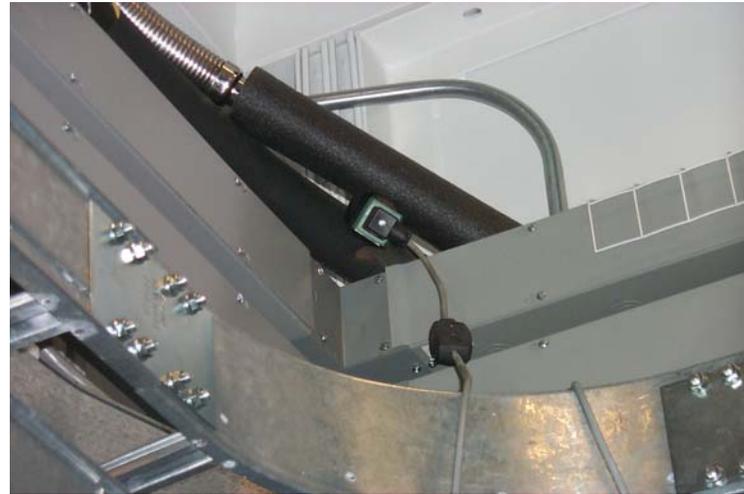
New solenoid in 7ID-A
